**UPPER PATUXENT RIVER WATERSHED RESTORATION ACTION STRATEGY (WRAS)
FORM 1 -- Catchment Information**

UPPER PATUXENT RIVER WATERSHED RESTORATION ACTION STRATEGY (WRAS) FORM 2 -- Site Information

Site Name: Crofton Bowling Centre Address: Priest Bridge Drive, Crofton, MD
 Site Owner: _____
 State Plane Coordinates of Site Centroid: X: 1397835 Y: 482200 Date: 5/13/03
 Personnel: PM Weather: cloudy, 70F deg
 Area (ac): 3.1 Impervious Area (ac): 3.0
 Percent Impervious: 95% Soil Recharge Factor (S): 0.38
 WQ_v (required): 0.24 Re_v (required): 0.09
 Property Area (ac): 3.8 Property Area Included in Site: 82%
 Amount of Catchment Occupied by Site: 56%

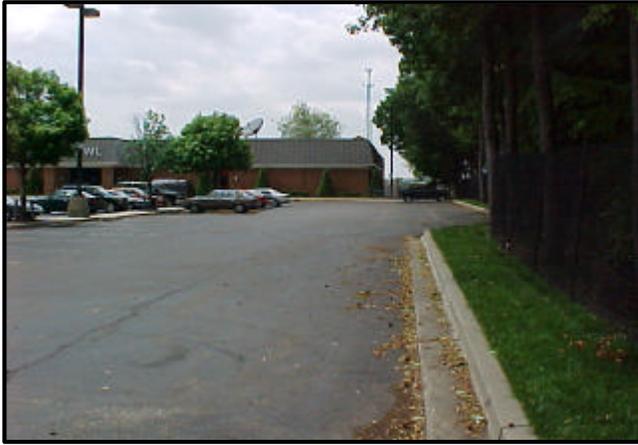
- No. 765 Description: looking west along north side of site
- No. 766 Description: looking south along east side of site
- No. 767 Description: looking southwest across parking lot to east side of building
- No. 768 Description: looking west along south side of site
- No. 769 Description: looking north along east side of site
- No. 770 Description: looking northwest across parking lot to east side of building
- No. 771 Description: looking east along south side of building
- No. 772 Description: looking north along west side of building
- No. 773 Description: looking south along west side of building
- No. 774 Description: looking east along north side of building

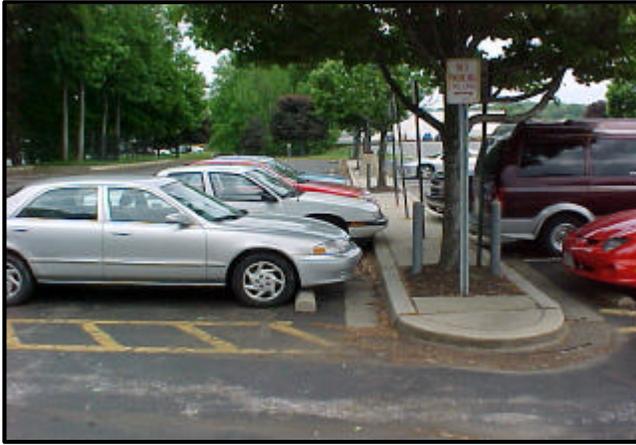
781

No. <u>781</u>	Description: <u>looking east</u>
No. <u>783</u>	Description: <u>looking west</u>
No. _____	Description: _____

Comments Concrete in island will be replaced with bioretention area. Connect areas with pipe to spare trees and lighting. Additional bioretention area will be obtained by using existing parking area. IMP provides 46% treatment of drainage area as sized.
IMP size = 1,294 sq ft

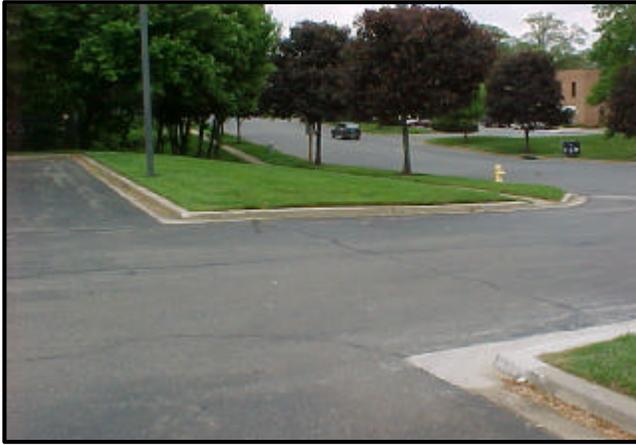
No. 785	Description: looking northeast
No. 786	Description: looking southwest
No.	Description:

Comments IMP treats flow entirely from site 46. Both IMPs 6 and 7 are in separate catchments.

IMP size = 1,204 sq ft

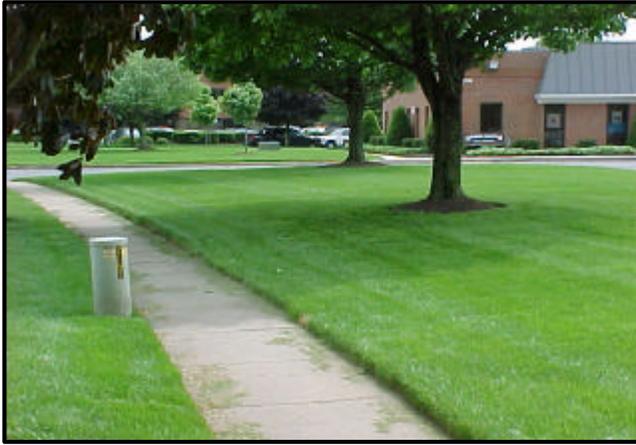
No. 787	Description: looking southwest
No. 788	Description: looking north
No.	Description:

Comments IMP treats flow entirely from site 46. Both IMPs 6 and 7 are in separate catchments.

IMP size = 359 sq ft
